**Lincoln Hancock Restoration  
Emergency Response Agreement – Inspection Report**

Name of Community: **Beachwalk**

Address: 111 Shipyard Drive Hilton Head, SC 29928

Date: July 11, 2013

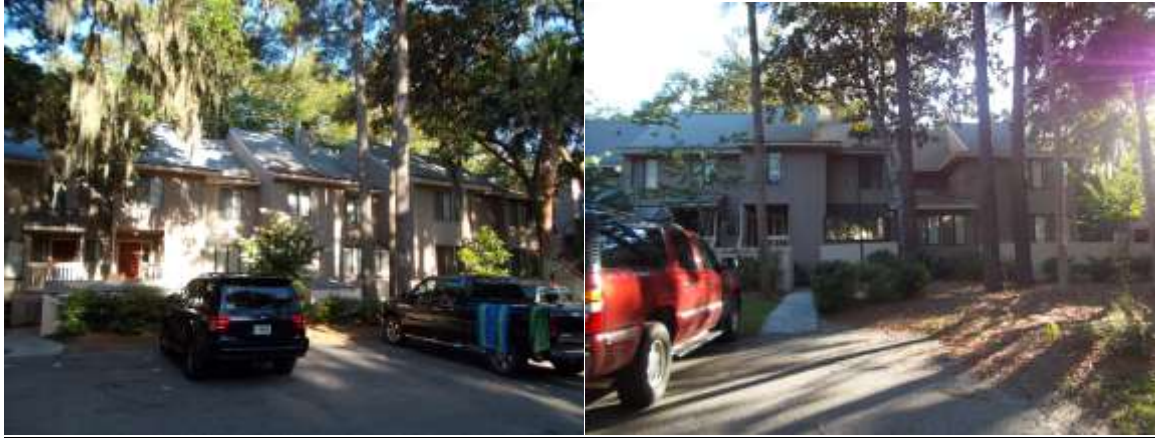
21. What type of roof system(s): Sloped

22. Condition and age of roof: 8+ Years
