**Lincoln Hancock Restoration
Emergency Response Agreement – Inspection Report**

Name of Community: **North Shore Place**

Address: 3 North Forest Beach Drive Hilton Head, SC 29928

Date: July 11, 2013

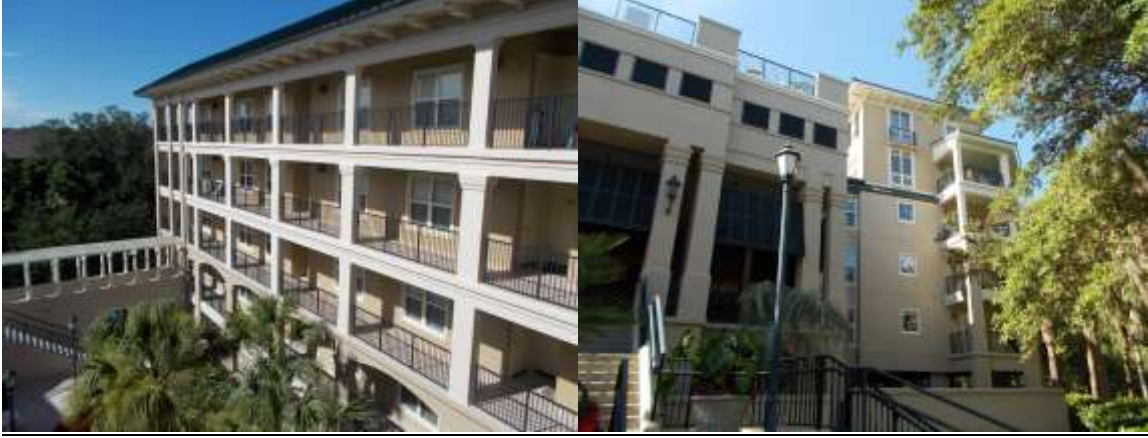
21. What type of roof system(s): Flat & Standing Seam Mansord

22. Condition and age of roof: 5-10 Years
